## Compendium of Monitoring Activities at Disposal at Sea Sites in 2001.

Disposal at Sea Program  
Marine Environment Branch  
Toxics Pollution Prevention Directorate  
Environmental Protection Service  
Environment Canada

December 2002

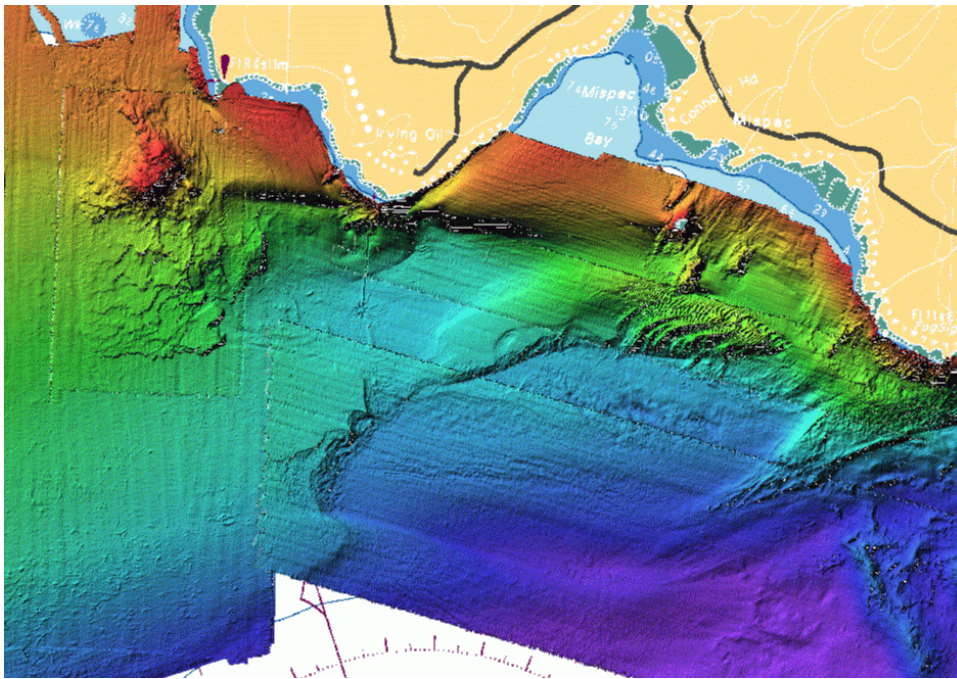
*Cover: Multibeam bathymetry of Black Point Disposal Site and surrounding area, November 2001, generated by Atlantic Geoscience Centre.*

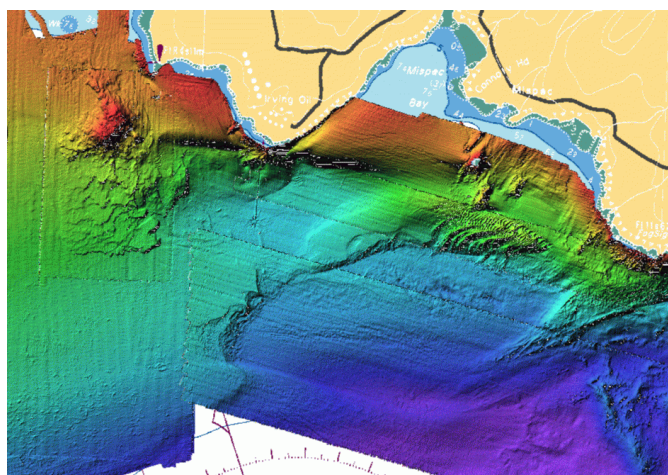
*Figure 1. Black Point Disposal Site and surrounding area*

Multibeam bathymetry surveys were conducted in April and November 2001, after dredging operations where the material was placed west of the previous disposal pile. The rough topography, observed on top of the disposal pile during the April 2000 and 2001 surveys, was still evident. A new spoil pile, from the 2001 dredging season, was evident west of the main pile.

These data, when integrated into previous surveys of the area, showed a large erosional scarp on the seafloor, south east of the large slump associated with the Black Point disposal site (Figure 1). Local fishers had reported recent changes in the nature of the seafloor for this area. While some erosion was observed from the disposal site, the vast majority of the erosional material observed was found to be consistent with the natural erosion of the surrounding area.

Preliminary interpretation of the multibeam bathymetry and geophysical data show that there were several activities and forces impacting the seafloor:

- the main spoil pile had slumped in previous years and flowed about 1.5 kilometres down the slope;
- material from the main pile was eroded during the winter storms;
- dredged material from relocated disposal activities during the summer and fall accumulated at a new pile west of the main pile;
- some dredged material remained relatively close to the main spoil pile;
- some dredged material was transported into deeper water along shallow troughs where it was deposited into bedforms; and
- a large erosional scarp was discovered southeast of the disposal site. The scarp appears to be the result of the erosion of fine grained sediments by the strong currents in the area. This erosion contributes sediment to sedimentary bedforms found at the base of the slump.

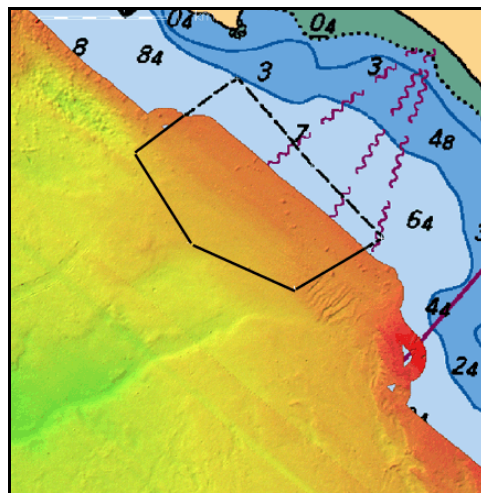
Images generated from the multibeam bathymetry data collected during surveys in 1995 and 2001 are shown in Figures 3 and 4. The data in Figure 3 show several discrete isolated mounds on the seafloor of dredge spoils from historical disposal activities within the approved disposal site. An area of sandwaves can also be seen in the lower right portion of the image, just outside the disposal site.

*Figure 3. Amherst Cove, 1995, before disposal of dredge spoils from Confederation Bridge shown with the boundary of the disposal site.*

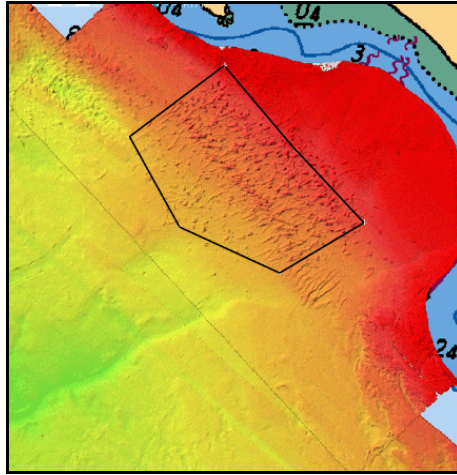
The multibeam bathymetry data from the 2001 survey have been overlaid on the data and are shown in Figure 4. The mounds from the 1995 survey are still visible, along with a large assortment of new dredge spoils from the construction of the Confederation Bridge. The area of sandwaves seen in 1995 is still visible in the lower right portion of the image. The majority of the disposed material was placed within the bounds of the approved site.

Figure 4. Amherst Cove, 2001, after disposal of dredge spoils from Confederation Bridge shown with the boundary of the disposal site.

Survey results indicated that disposal was conducted within the boundary of the designated disposal site and seemed to create an area stable in the local dynamic physical marine environment. The fine materials detected from the disposal site may have come from other areas through local sediment transport after the construction of the bridge. Based on the video survey and bottom photographs, it seemed the mitigation measures adopted by the proponent had been able to support or attract shellfish.

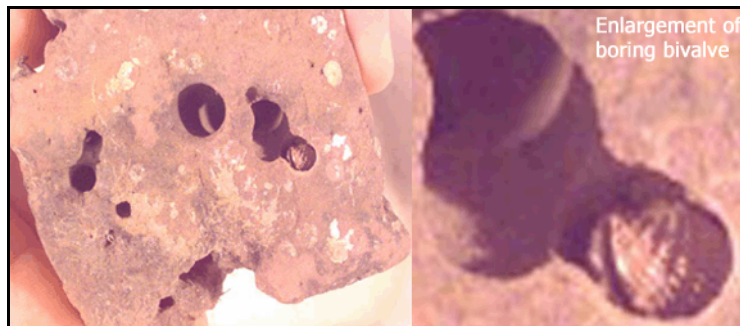
The grab samples of the seafloor showed a wide variety of sediment ranging from fine sediments in the deeper water areas to gravel, cobbles and boulders. Large pieces of bedrock were observed in video transects through the disposal site. Some of the pieces showed holes that had been bored into the rock from a species of boring bivalve which were found at the site (Figure 5). In Atlantic Canada, these bivalves are found only in the Bay of Fundy and near Prince Edward Island where they inhabit the soft mudstone/sandstone rock present there.

Figure 5. Sample of sandstone cobble recovered from Station 30 showing boring bivalves in the rock.
